The Holes Creek Bridge Replacement By Bradley McClelland

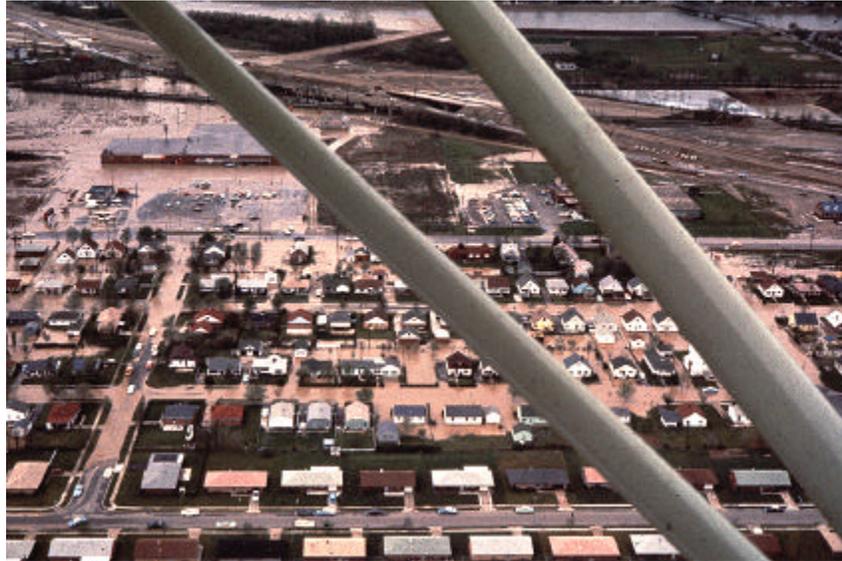
This aerial view of West Carrollton, Ohio during one of the many floods of Holes Creek. This view is looking southwest; the railroad right-of-way is located in the top left-hand corner. Unknown photographer

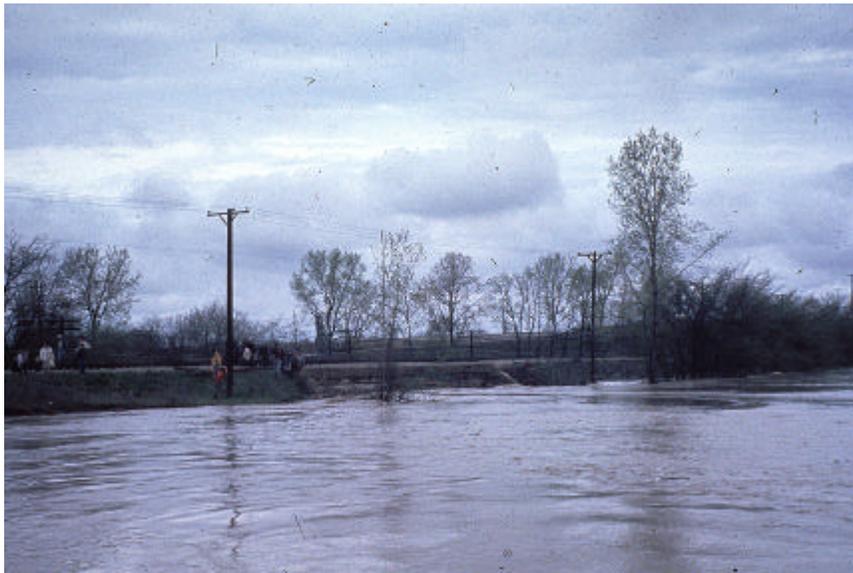
In this image you can see why the railroad bridge needs to be replaced. Logs and other debris became wedged against the bridge supports, which caused this flood. Photo taken in April 1961 by W.Allen McClelland

The flooding problem has been getting worse in recent years. Construction of new homes and retail centers in the area altered drainage patterns and increased the water flow in the creek. This exacerbated a design problem in the Holes Creek Railroad Bridge. The bridge, built in 1906 by the Cleveland, Chicago, Cincinnati & St. Louis Railway---the Big Four---did a wonderful job of supporting the rails at MP 213 of what is now Norfolk Southern's Dayton District. However, it had an unfortunate tendency to catch logs, downed trees and other debris during high water thanks to the three concrete supports in the creek bed. Too, the railroad right-of-way was built on a fill, which served to keep the tracks above floodwaters, but deepened the difficulty for the rest of the neighborhood.

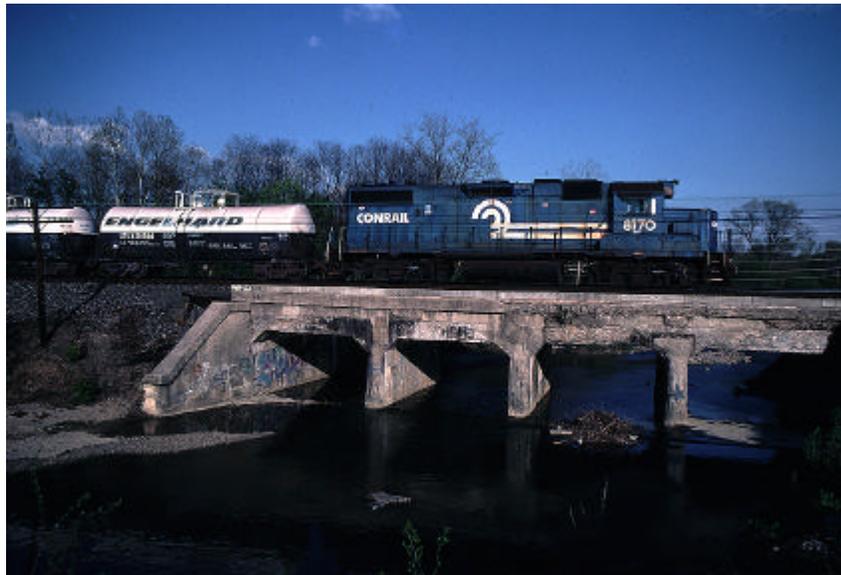
Conrail Local YSMO-23 heads west over the Holes Creek Bridge in the late afternoon. We are looking upstream to the east on April 29, 1999. Large trees were removed along the creek bank by April, making this once closed in photo now open.

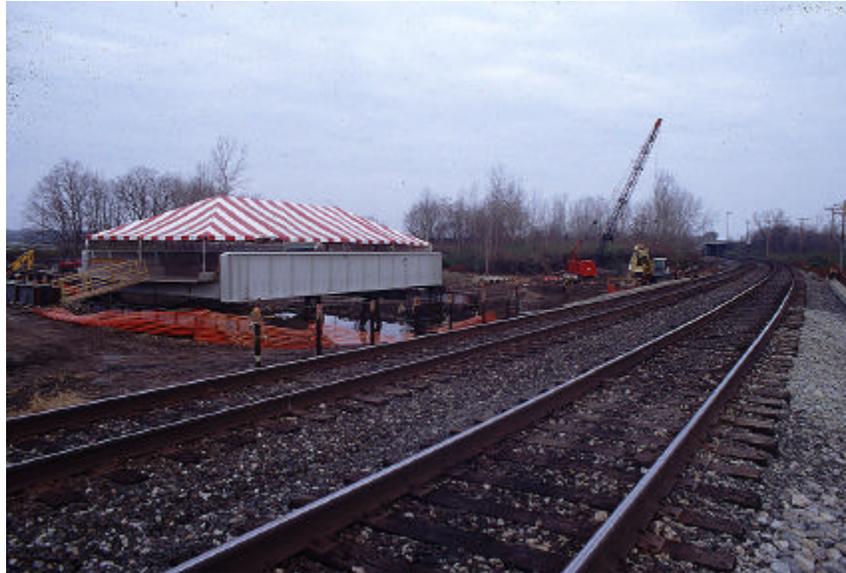
In this photo we are looking north towards Dayton, Ohio on Norfolk Southern's Dayton District near MP 213. Image captured in November 1999. Photo by Bradley McClelland

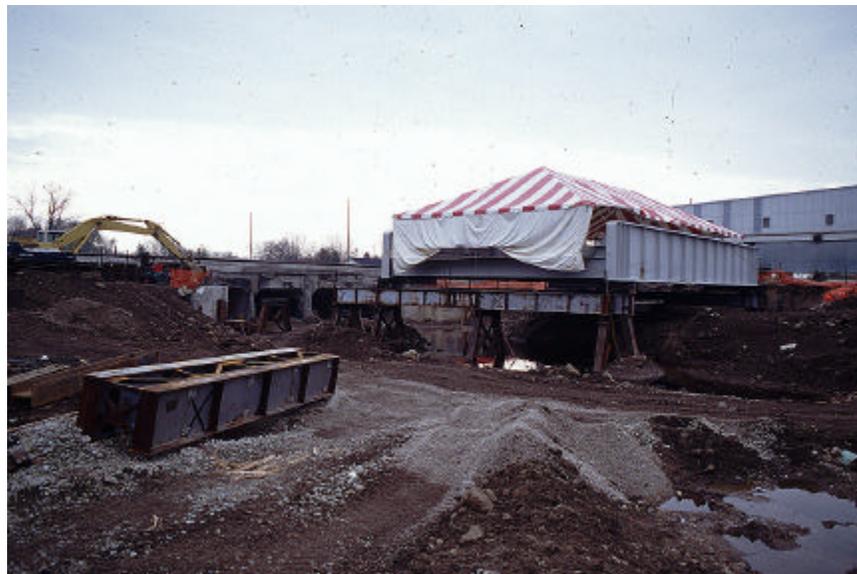
This is a good view of how the through girder bridge was built above the stream bed. The double steel I beam on the ground to the left will be added to the rest of horizontal I beams, The new bridge will roll on top of horizontal I beam to the tracks. We are looking south in the picture. Photo by Bradley McClelland

The next step was to build the new steel bridge, which would be a through-girder type to maximize the bridge's height above the water. Just to the west of the Big Four bridge, pile drivers drove steel I-beams into the creek bed atop which crews laid horizontal I-beams, like a pair of

giant sawhorses, structures which would serve as the steel bridge's construction platform. In addition, "wheels" were built under the steel structure and a series of rails leading from the fabrication site to the tracks was added, so that, when the time came, the new bridge could be rolled close to its intended destination.

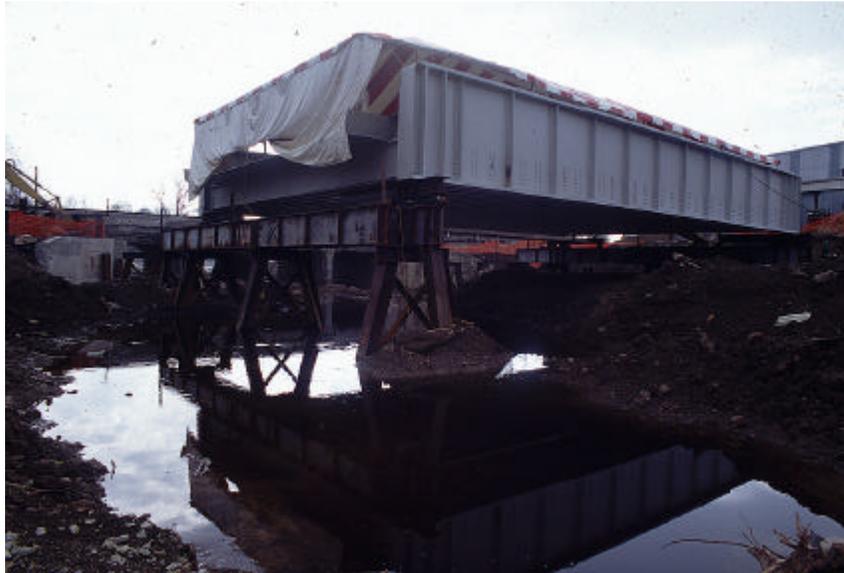
In this view we are looking east from the creek bed. This is a good view on how the bridge was supported above the stream during construction. There were no problems with high water during this project, they were lucky, it was a dry late fall and early winter. Photo by Bradley McClelland

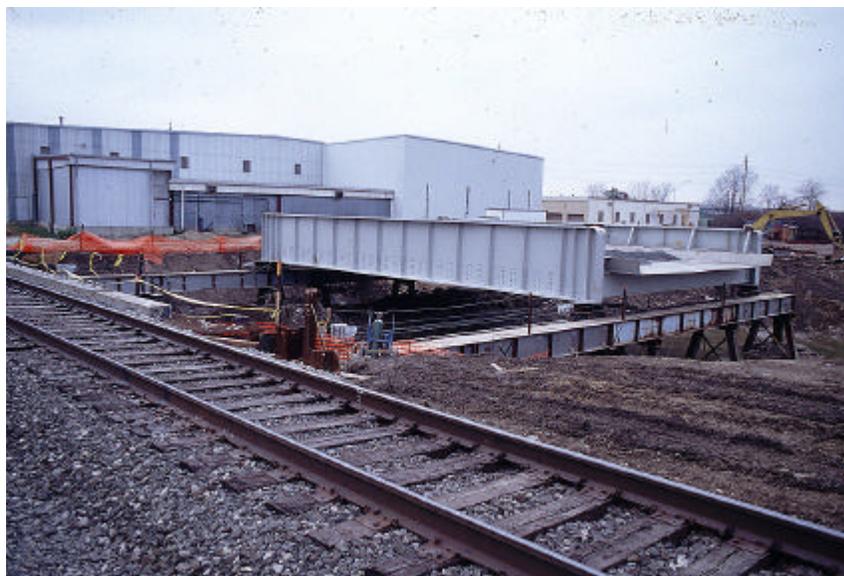
Looking south in photo, we can see how close the warehouse is to the creek and railroad. This was a deciding factor in why a detour track wasn't built around the old concrete bridge. Photo by Bradley McClelland

Now, how do you replace a bridge without hindering train traffic? In this case, two problems exist. First the railroad crosses the creek on a sweeping curve. Secondly, homes and a large warehouse were built close to the tracks and creek bed; so there was no room to build a detour track around the old bridge. Room could be made to fabricate a new, steel bridge to the west of the existing structure and then move it into place. Electric power lines that paralleled the tracks had to be relocated and trees and vegetation had to be removed to gain easy access to the site.

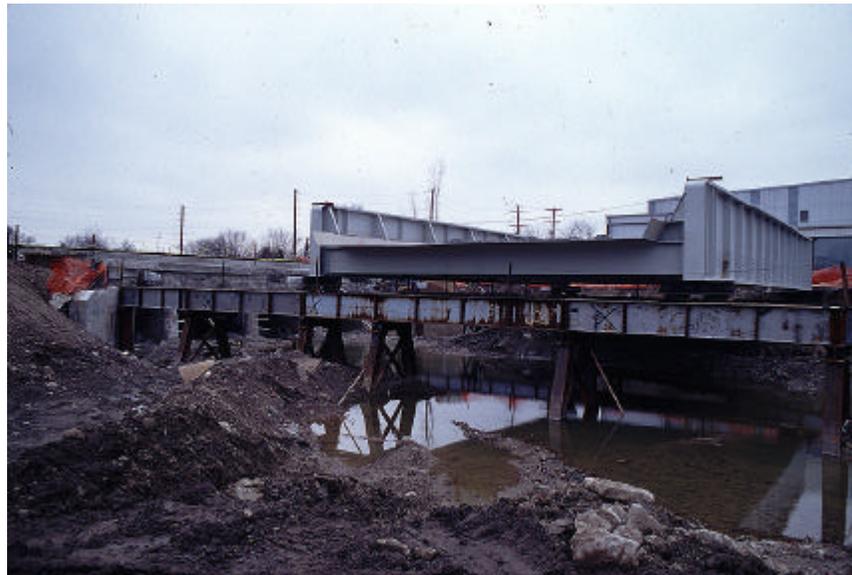
Photographing the new bridge from the creek bed shows the new bridge completed. The last of the horizontal I beams was installed closest to the old bridge. A layer of track blast was placed on the deck of the new steel bridge. By the middle of December, the new bridge was less than two weeks away from being installed.
Photo by Bradley McClelland

The new steel bridge weighed in at 500 tons upon its completion in late November 1999, and with a layer of ballast on the deck, it was ready to be placed into service. The old Big Four Bridge that carried trains over Holes Creek since 1906 would not see the new Millennium. The date for demolition was set for December 30, 1999.

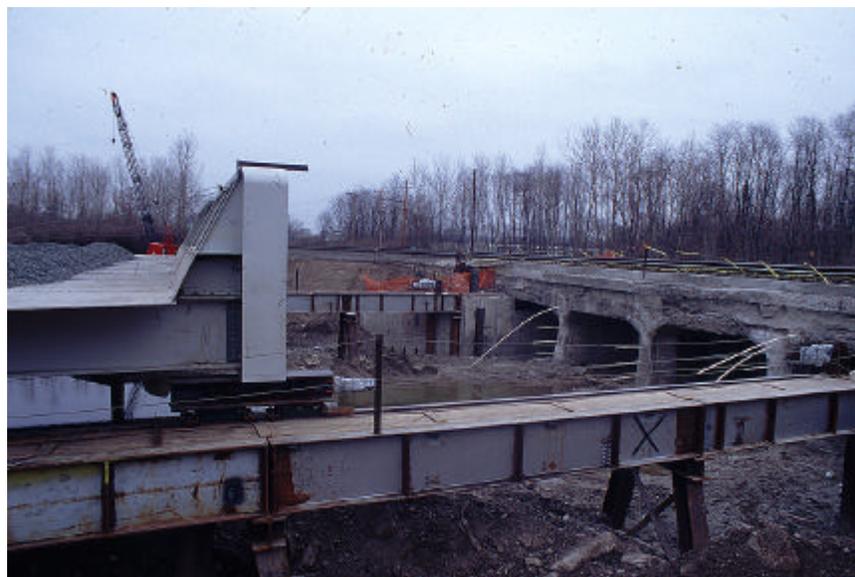
Looking north at the bridge project, here is a good view of the PVC pipe on the old bridge. Workers drilled deep holes in the deck and supports of the old concrete bridge, and then PVC pipe was inserted into the drilled holes. This will guide the dynamite in side the old bridge.

higher thanks to the way the steel bridge would be pinned to the concrete), which made that construction possible. Other laborers drilled long holes deep into the Big Four bridge's concrete, into which would be placed a PVC pipe lining and, later, dynamite. The last step was to cover the sides of the old concrete bridge with a steel mesh that looked like chain link fence, which would serve to contain the piece of concrete during the demolition of the old bridge.

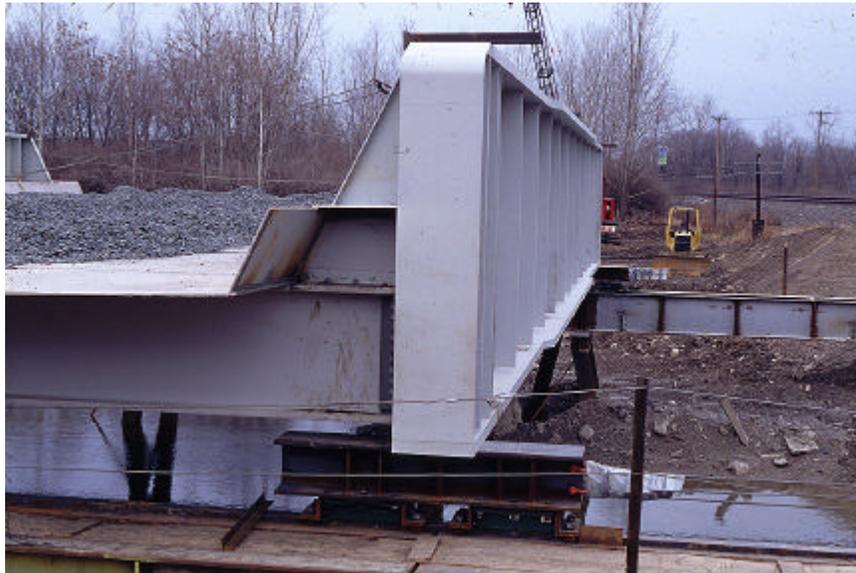
This is a photo of the southeast section of the bridge, which shows a good view of the rollers or steel wheels under each corner of the bridge. The rollers will ride on top of a steel rail, which rest on top of the I-beams. A large nut and bolt runs vertical through each roller, which acts as a flange and guides the roller and the new bridge to old bridge. Also in this image you can see the cables attached to the rollers. This prevents any movement during the building of the new bridge. Photo by Bradley McClelland

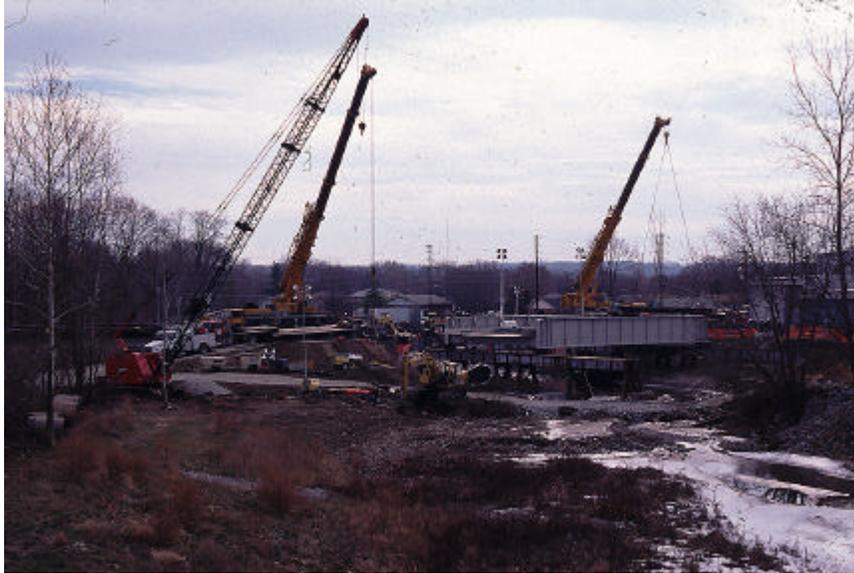
In this view we can see that the old concrete bridge was removed. Two large yellow cranes spotted on the tracks will lift the new steel bridge to its final home. The one crane on the south bank has its cables connected to the new bridge. In the creek bed where the old bridge used to be, a backhoe with air hammers blast away at the remaining concrete supports. Too the far left, a stack of new track is waiting to be placed on the steel bridge.

After machinery cleared the debris, the new bridge was winched eastward to a point where two large cranes lifted its ends and set it in place. It was then bolted down to the concrete abutment. New ties and rail were put in place. Track equipment rushed to the scene to tamp and straighten the track over the new bridge. In the early morning of Friday, December 31, 1999, the first train went over the new bridge. It was a lowly work train, powered by two ex-Conrail GP38-2s, dumping ballast on the new span. Track equipment came next to tamp the track. Just before the new Millennium rang in, the new, steel Holes Creek Bridge was ready for its first freight train.

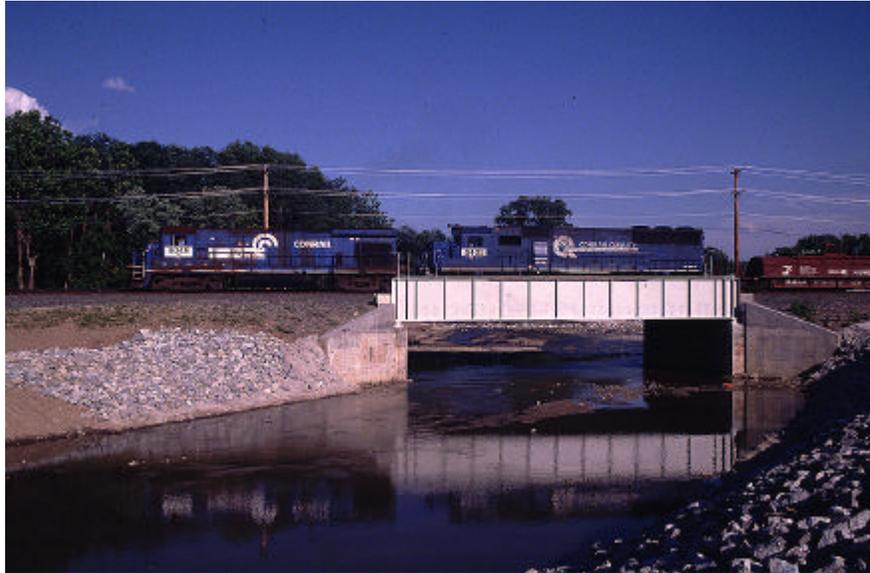
Norfolk Southern train # XON (second section of 40N) with two former Conrail units travel east across the new Holes Creek Bridge. The bridge project was near finish; more rock needed to be placed along the creek bank. The last step was to plant grass and trees to help prevent erosion. Photo taken on July 20, 2000 by Bradley McClelland

Beginning in March, more concrete was poured around the abutments. The electric power lines and poles were restored and earth around the work site was graded. The creek bed was improved for a direct follow of water under the bridge. Rock was shipped in and placed along the banks of Holes Creek to help reduce erosion during high water. Finally in the early September 2000, the endeavor was complete!
